THE KJØRBO INCIDENT

Press conference
June 28, 2019

Kjørbo incident

Root cause

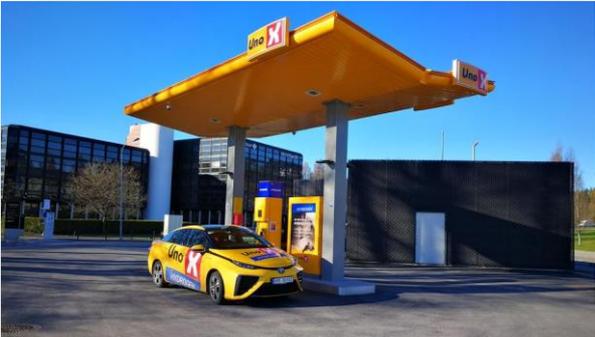
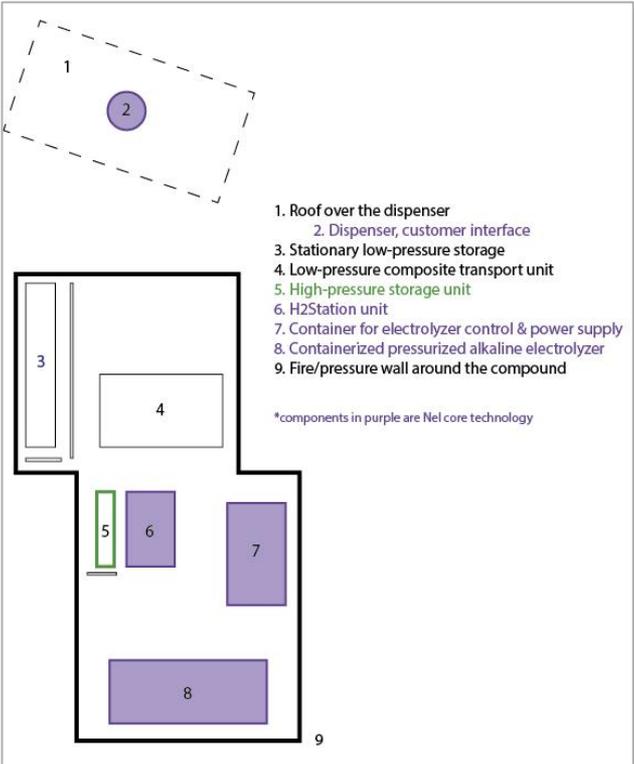
The Kjørbo site

- Opened 2016
- Owned by Uno-X Hydrogen
 - JV between Uno-X, Nel, and Nippon Gases (formerly Praxair)
- Nel H2Station® with on-site hydrogen production from electrolysis
 - Product family: CAR-200 Europe

Drawing for illustrative purposes only. Not to scale.

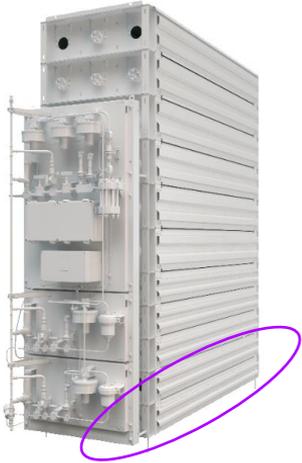
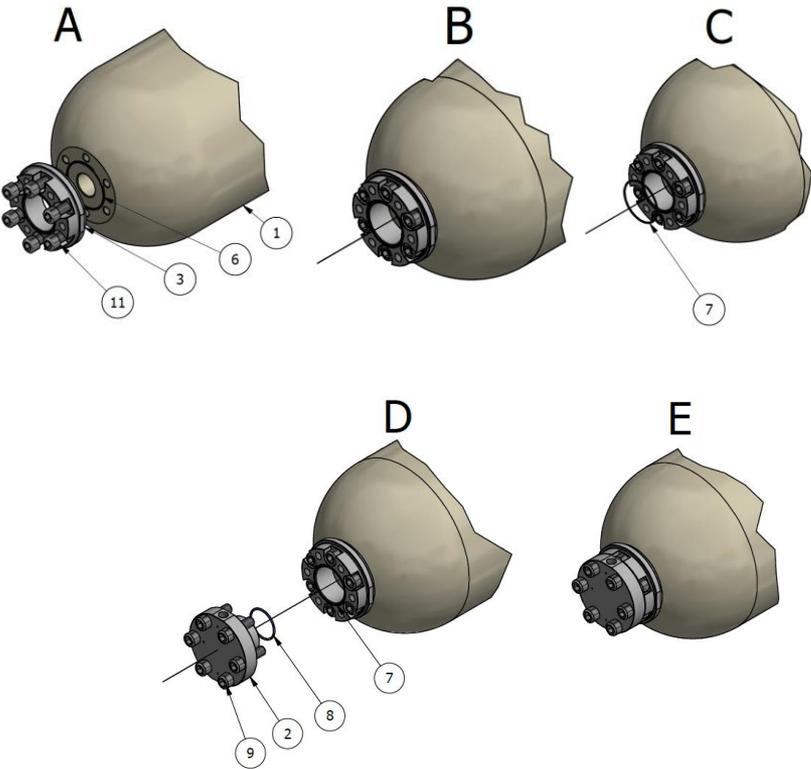
Preliminary conclusions

Non-core Nel technology

- Assembly error in high-pressure storage unit
- Unit consists of steel tanks and other components by third parties, some of which are designed by Nel

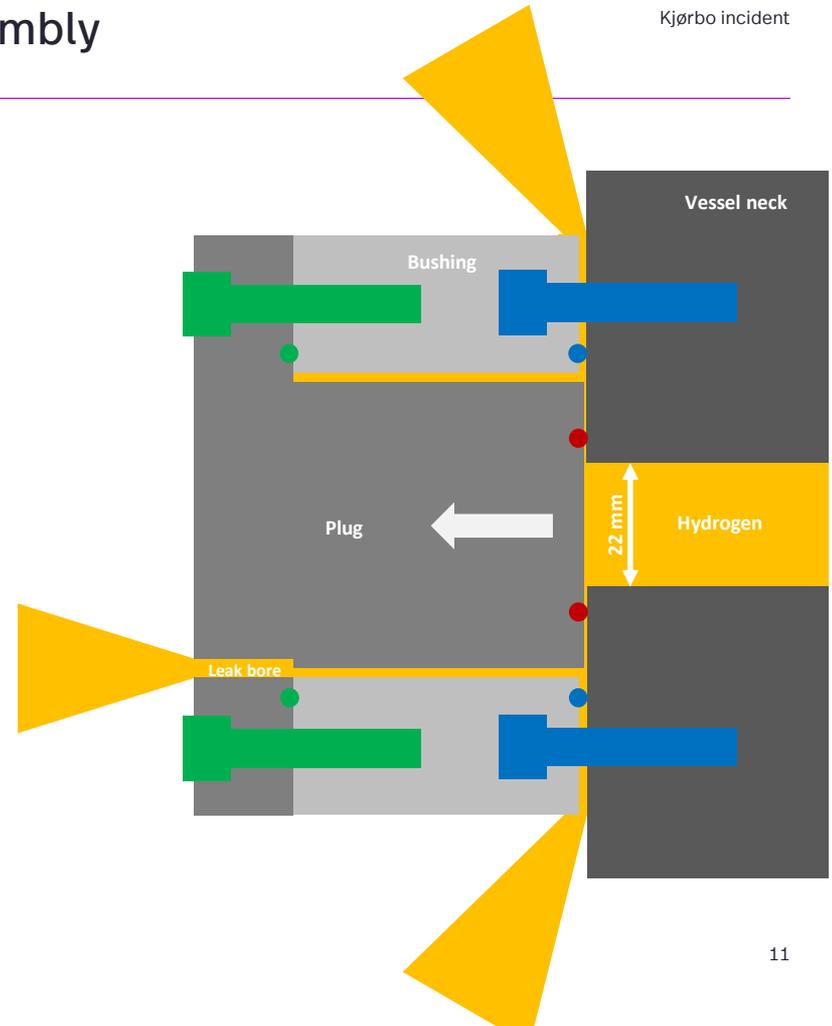
Root cause - failure mechanisms of plug assembly

1. Starting condition

- Green bolts torqued properly
- Blue bolts not torqued properly

2. Red sealing fails

- Starting with small leak on red sealing area
- Small leak wears red sealing out and escalates
- Large leak exceeding capacity of leak bore, causing pressure increases inside blue sealing area

3. Bushing with Plug lifts and the blue seal fails

- Insufficient pre-tension of bolts leads to lift of the plug and blue sealings fail immediately
- Spread of Hydrogen leaks out in uncontrolled way
